Manhole Inspection Summary

Manhole # S43E__020MH

Insp Date: **1/5/09 10:21 AM**

Location Address: **1600 E BALTIMORE ST**

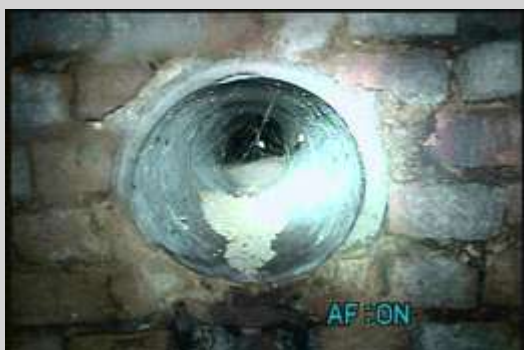
3 O'Clock Inflow

Pipe Height: **8.4** (in.) Rod and Bar (Angled)
Pipe Material: **Clay** ☐ Pipe Lined
Invert Depth: **13.70** (ft.) Flow Characteristics: **Slow**
Deposits: ☒ None ☐ Mud ☐ Sludge ☐ **Debris** ☐ Grease
Silt Depth: **0** (in.) Deposits Extent:
Infiltration: **None** Pipe Seal Cond: **Sound**
